by Larry Frash

# Familiar Failures and Faithful Fixes for the Mazda FN4A-EL and Ford 4F27E

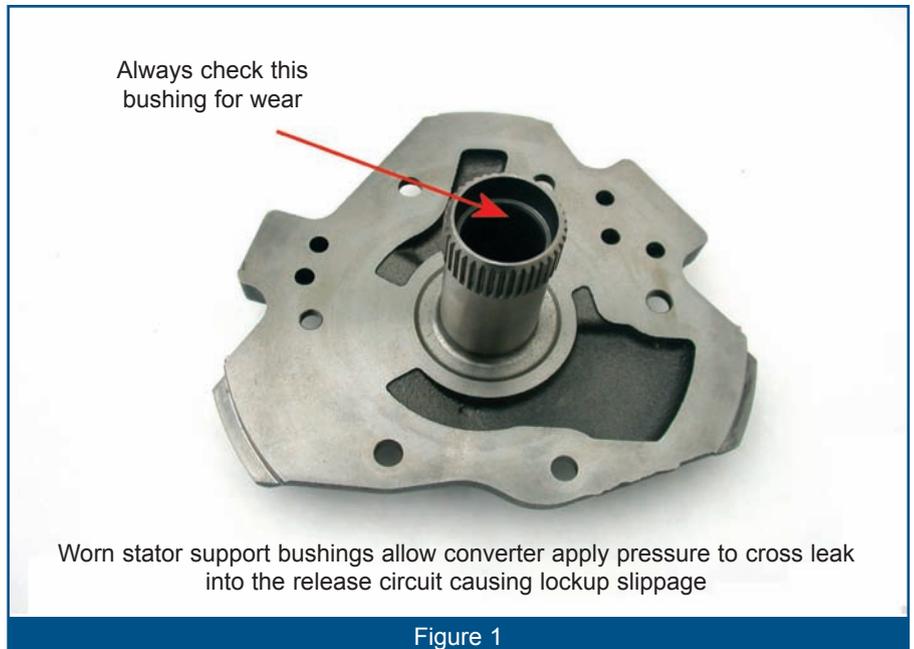
Figure 1

The stator support bushings support the turbine shaft (figures 1 and 2), but they also separate the TCC apply and release pressures. With lockup released, converter charge pressure is delivered between the converter clutch and the apply surface (the front converter cover). This hydraulic pressure is called *converter release pressure*, and that pressure is what keeps the converter clutch from applying.

When the stator support bushings are worn, they can allow converter apply pressure to leak into the release side of the converter. When this occurs,

converter release pressure can't exhaust fast enough, so it keeps pressure on the release side of the converter clutch. This prevents the converter clutch from fully applying, which causes the converter clutch to slip.

To avoid this problem, always check for wear between the stator support bushings and turbine shaft, whenever you're rebuilding one of these transmissions. If you find more than 0.0015" clearance, replace the bushings. These bushings are made by Omega Machine & Tool, Inc. and are available from a number of sources in the aftermarket.

Once you've replaced the bushings, slide the stator shaft into place and recheck the clearance between the shaft and the bushings; while not particularly common, it is possible for the shaft itself to wear and need replacement.

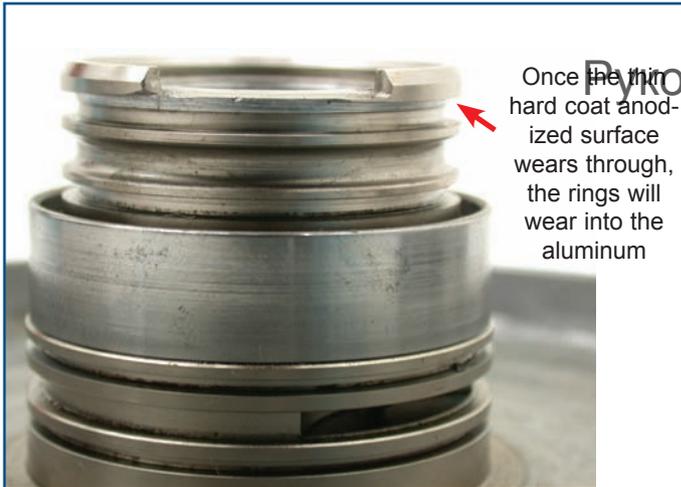
Figure 3

Once the thin hard coat anodized surface wears through, the rings will wear into the aluminum

It's not uncommon to see wear in the end cover, around the top direct

clutch ring land area (figure 3). On Mazda applications, the end cover is aluminum and is hard coat anodized around the ring land area (figure 4). This hard coating is designed to prevent the rings from wearing into the soft aluminum. Once the thin anodized coating wears through, the ring wears into the bare aluminum, destroying the cover.

So, to avoid wear in the end cover, you should always use the Ford cover. Whenever you rebuild an FN4A-

EL/4F27E transmission, check the end cover carefully to see which one is being used. Never reuse the hard coat anodized cover, even if there's no sign of wear in the ring area. Always replace the Mazda-style end cover with a Ford cover, part# XS4Z-7222-BA. This cover will work on all models, with a few minor modifications:

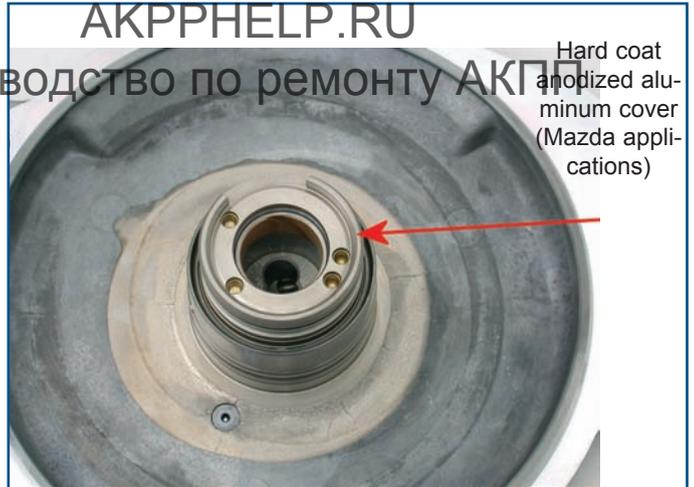
Figure 4

Hard coat anodized aluminum cover (Mazda applications)

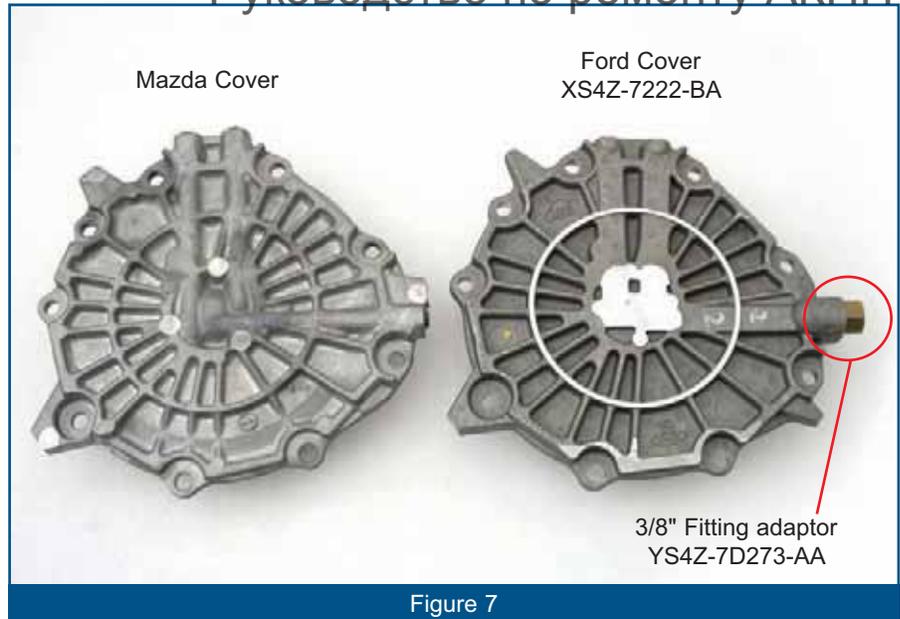
lube oil to the transmission. The Ford version of this transmission has the cooler return line threaded directly into the end cover. Because of this, the Ford end cover doesn't have the cooler return passage from the case that the Mazda cover has (figure 7 and 8).

To adapt the Ford cover for use with a Mazda transmission, you must reroute the cooler return circuit. Here's how:

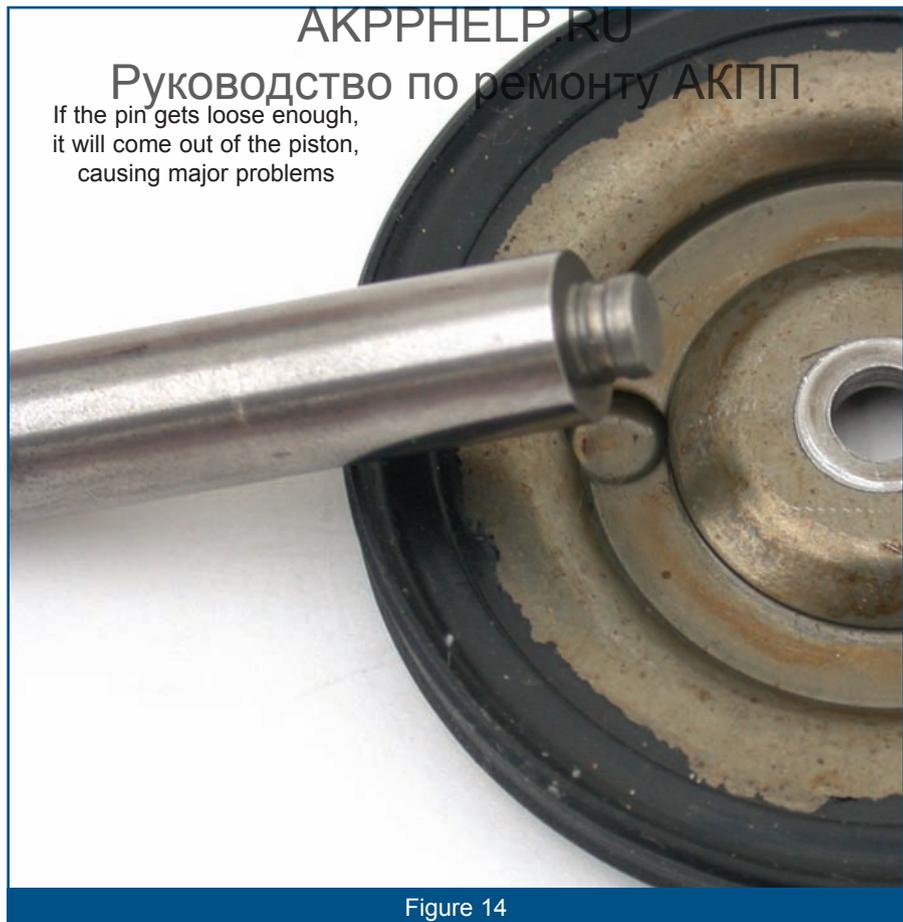
Figure 14

The intermediate/overdrive band servo is a molded rubber piston with a pressed-in pin (figure 13). Problems occur when the pin becomes loose in the piston and causes leaks between the apply side and the release side of the servo. Symptoms of a loose pin can include:

But the most common symptoms caused by a loose servo pin are a slip in 4<sup>th</sup> gear and 4<sup>th</sup> gear ratio codes. If the pin gets loose enough, it will come completely out of the piston, causing major problems (figure 14). To avoid problems from this servo, always replace the servo with a new one during every rebuild.
