by Larry Frash

# Familiar Failures and Faithful Fixes for the Mazda FN4A-EL and Ford 4F27E

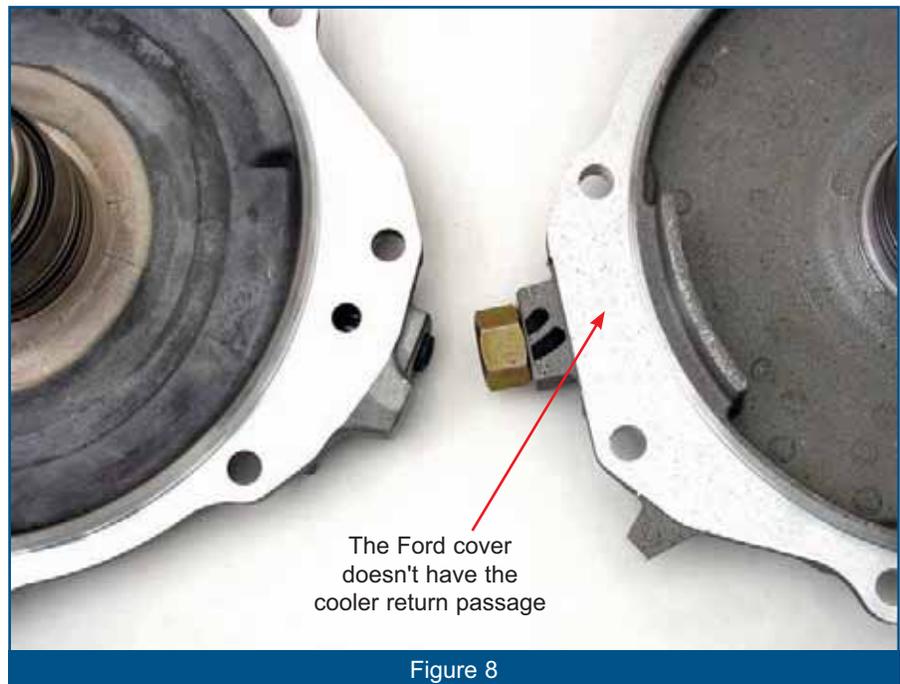
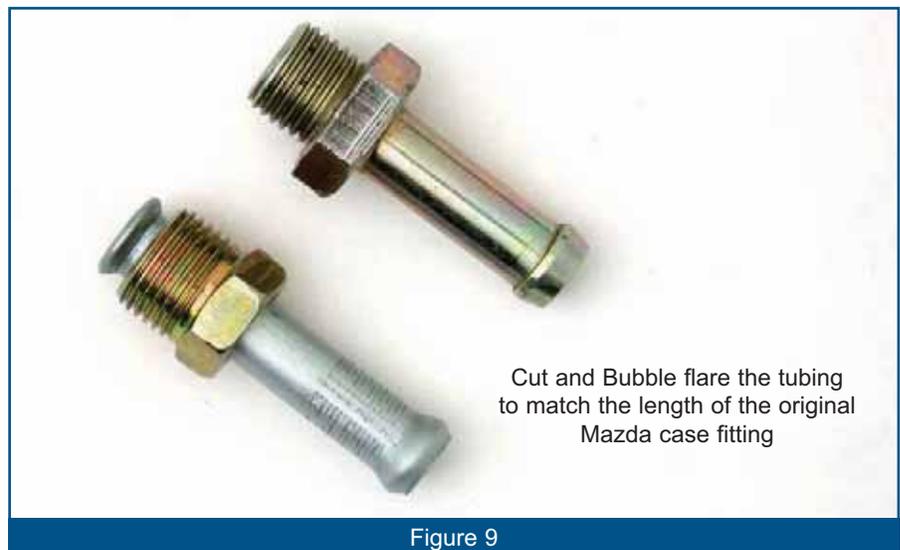
Using a piece of 3/8" cooler line, cut and bubble flare the tubing to match the length or the original Mazda case fitting (figure 9). As you can see, a bubble flare isn't a full flare. It's only flared enough to hold the rubber hose onto the line when it's handling pressurized fluid. Pay attention to this when flaring the replacement line: If you flare the tubing too much, the flared portion of the tube will be too sharp and will eventually cut through the rubber hose.

Remove the original cooler line fitting from the Mazda case to use it as a template to make a new fitting. The threads are different and won't fit the Ford end cover. When you order the Ford end cover, also order a 3/8" fitting adaptor from Ford, part# YS4Z-7D273-AA. Install it into the Ford end cover.

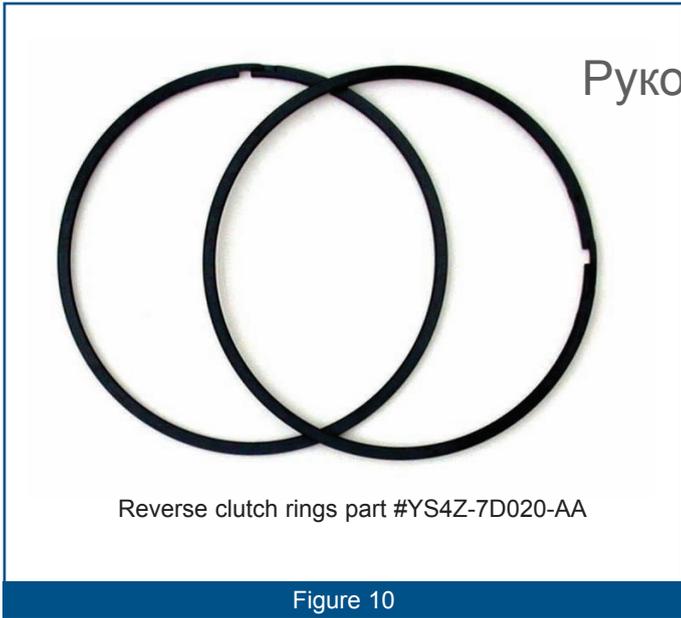
Because the Ford end cover ring lands are made of steel, always use the Ford rings. The part number for the reverse clutch rings is YS4Z-7D020-AA (figure 10). The part number for the direct clutch rings is YA4Z-7D019-AA (figure 11).

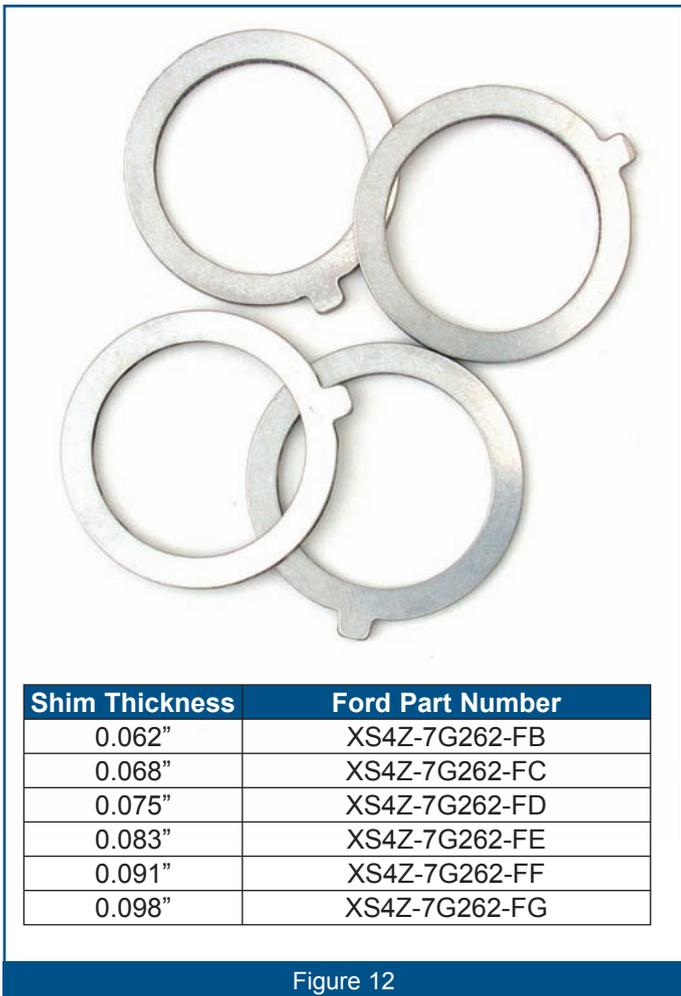
endplay for this transmission is 0.010" to 0.019". Corrective shims for adjusting endplay are available from Ford, and range from 0.062" to 0.098" (figure 12).

Any time you change hard parts in a transmission, always check the endplay. Proper

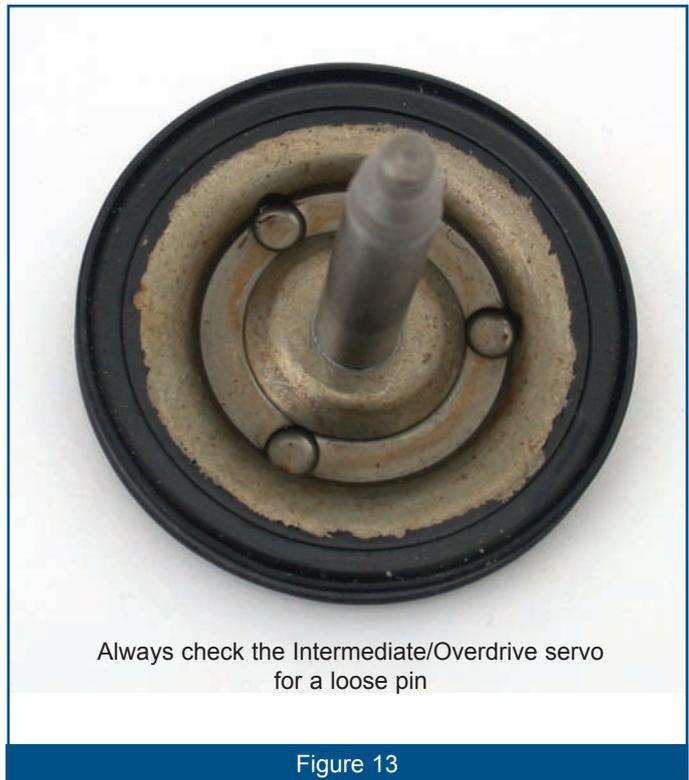
The intermediate/overdrive band servo is a molded rubber piston with a pressed-in pin (figure 13). Problems occur when the pin becomes loose in the piston and causes leaks between the apply side and the release side of the servo. Symptoms of a loose pin can include:

- Ratio errors
- 2<sup>nd</sup> gear slip
- 2-3 flare
- 3<sup>rd</sup> gear slip

But the most common symptoms caused by a loose servo pin are a slip in 4<sup>th</sup> gear and 4<sup>th</sup> gear ratio codes. If the pin gets loose enough, it will come completely out of the piston, causing major problems (figure 14). To avoid problems from this servo, always replace the servo with a new one during every rebuild.
